**PRESERVING THE SCHOONER  
*C.A. THAYER***

**MGA J. O. No. 1650**

**Morris Guralnick Associates, Inc.**  
130 Sutter Street, Suite 400  
San Francisco, California 94104-4015  
(415) 362-1242; Fax (415) 362-2619  
10 July 1991  
Revised 9 January 1992

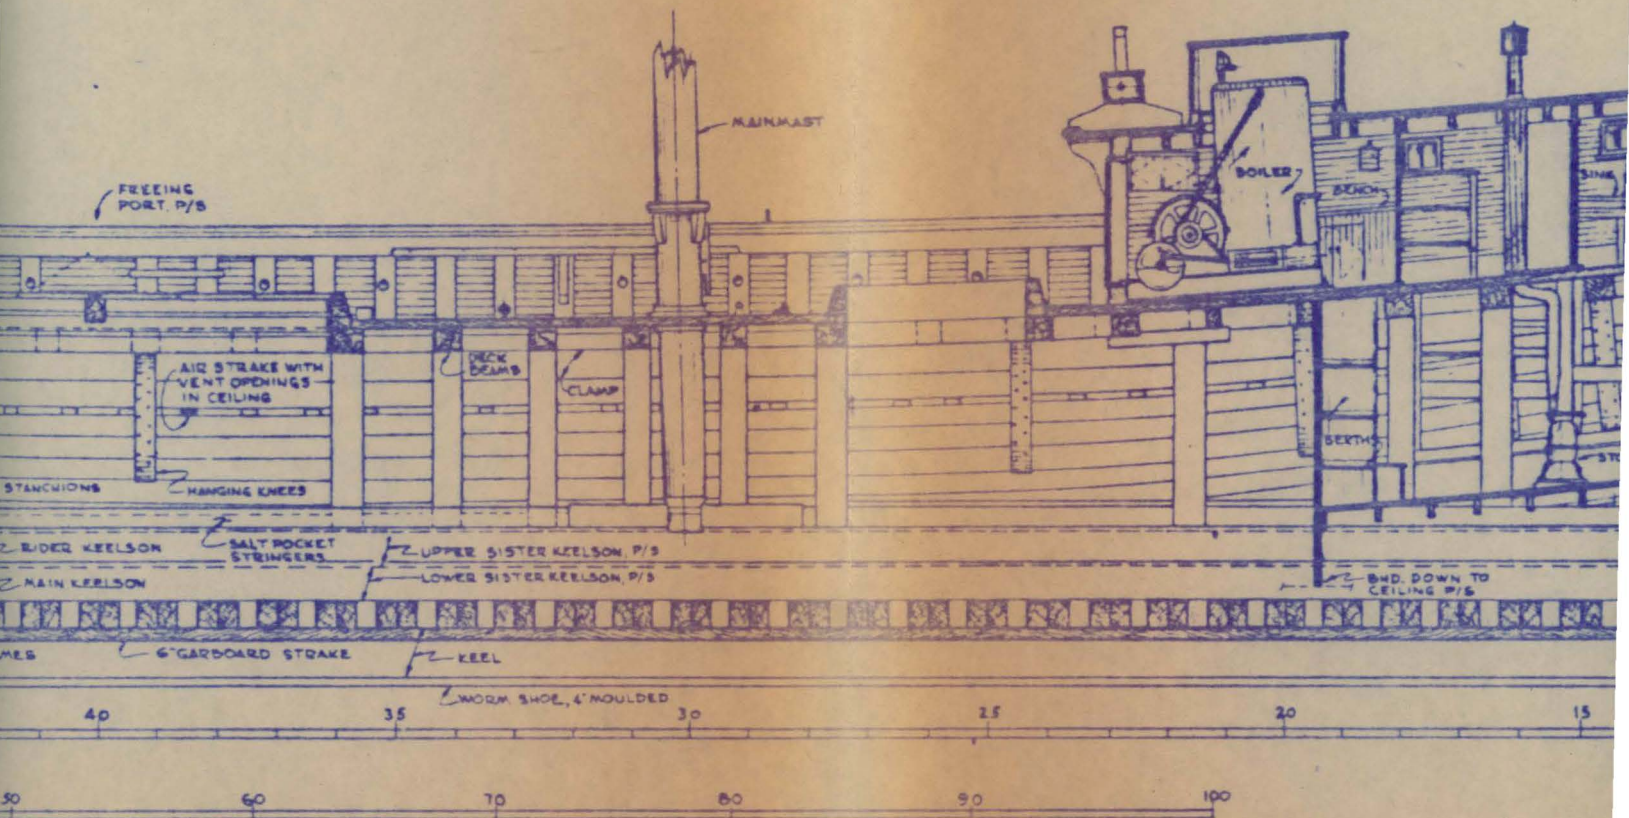
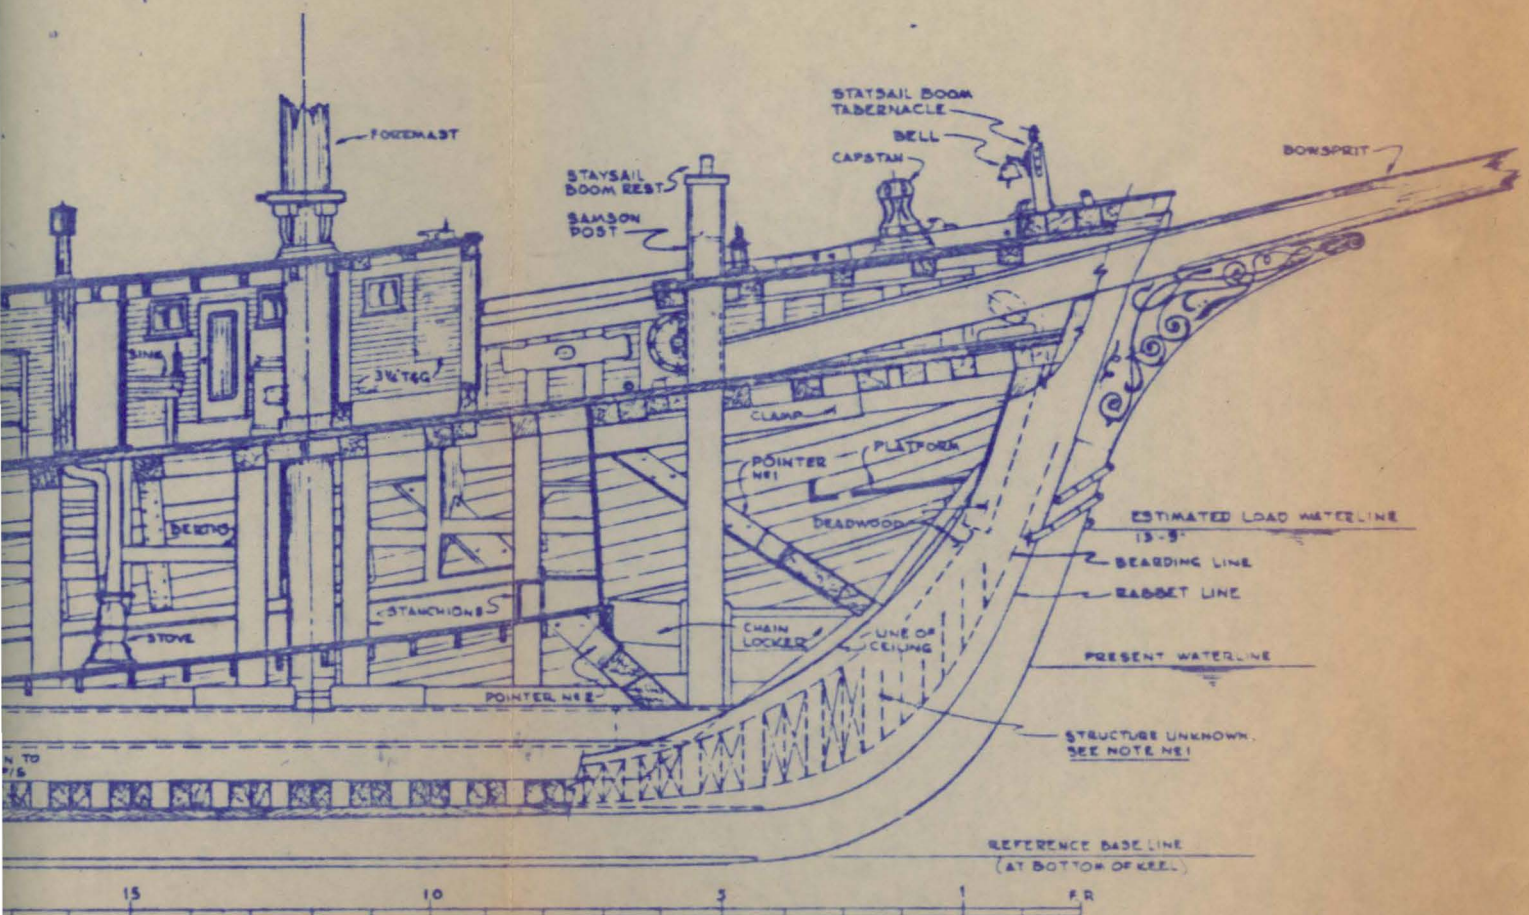
INBOARD PROFILE

1. INTERNAL HULL STRUCTURE AT THE BOW AND STERN HAS NOT BEEN DOCUMENTED DUE TO LACK OF ACCESS. ARRANGEMENT AND DIMENSIONS GIVEN ARE APPROXIMATE ONLY.
2. VESSEL IS SHOWN WITHOUT EXISTING HOG. HOG HAS BEEN MEASURED AT 14" (DEC, 1988) WITH MAXIMUM HOG AT FRAME 34.
